# Renovation of a heritage-protected building owned by the Swiss National Bank

**The Swiss National Bank recently renovated a 130-year-old property located at 8, Fraumünsterstrasse in Zurich. With the aim of securing earthquake resistance and accommodating new building functions, EBP completed the planning for the modification of the load-bearing structures.**

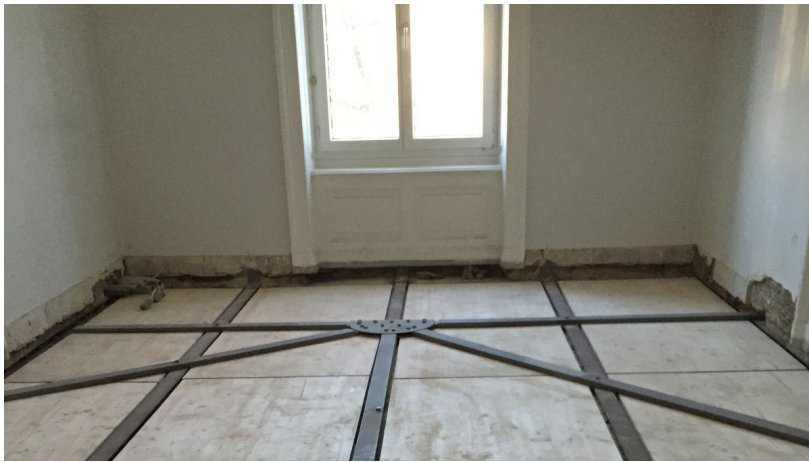
Ceiling structures (Picture Credits: EBP)

The execution of the construction measures in a heritage-protected building presented a special challenge, especially given the need to preserve the valuable stucco ceilings and coordinate the efforts of multiple contractors. For instance, we needed to carefully harmonize the arrangement of the earthquake-resistant, horizontal steel-truss structures with all cable ducts and floor structures.

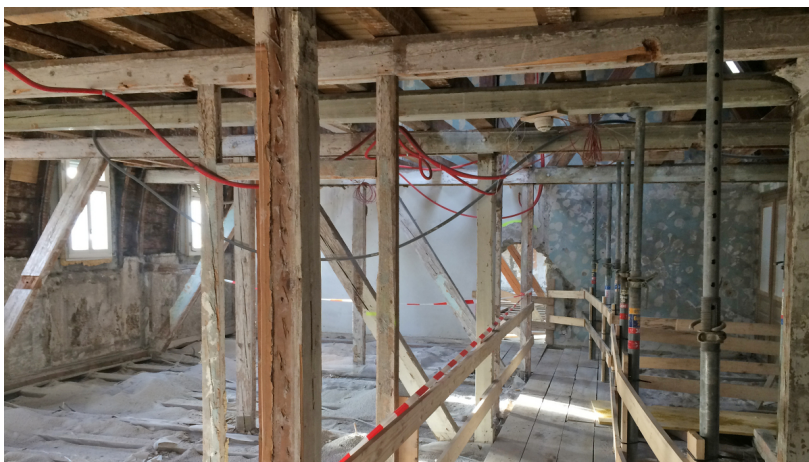
Exposed attic (Picture Credits: EBP)

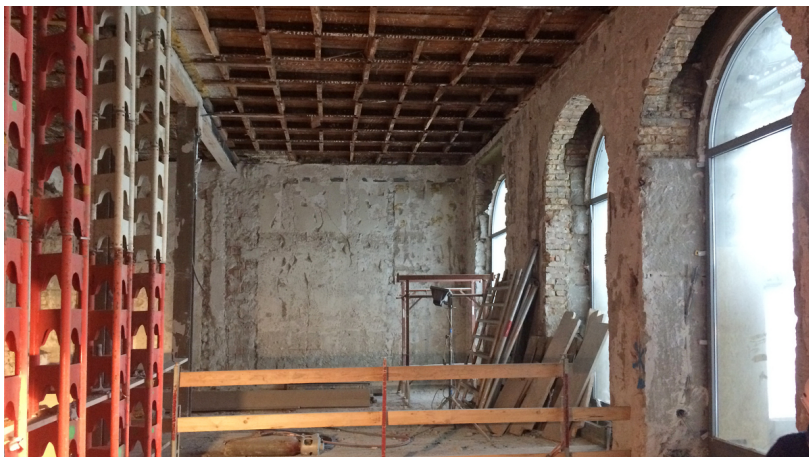
Wood-beam ceilings on first floor (Picture Credits: EBP)

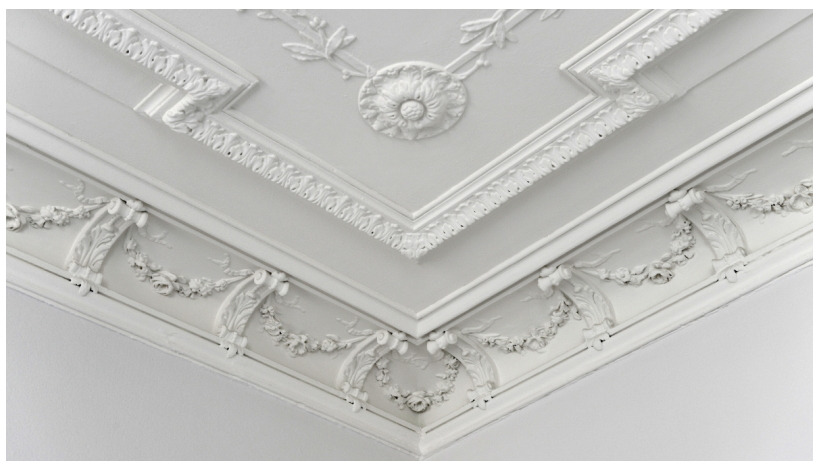
Preserving the delicate stucco work (Picture Credits: Marco Blessano)
